Agenda  
Hearing Examiner Meeting  
Thursday, March 23, 2023  
Richland City Hall ~ Council Chambers  
625 Swift Boulevard  
[Zoom](#) ~ Public Telephone Access: (206) 337-9723 or (253) 215-8782  
Meeting ID No. 872 2126 7401

1. Z2022-106 Rezone Peach Tree Estates from Agriculture (AG) to Medium-Density Residential Small Lot (R2-S)
2. S2022-105 Peach Tree Estates Preliminary Plat

Z2022-106 Rezone Peach Tree Estates from Agriculture (AG) to Medium-Density Residential Small Lot (R2-S)

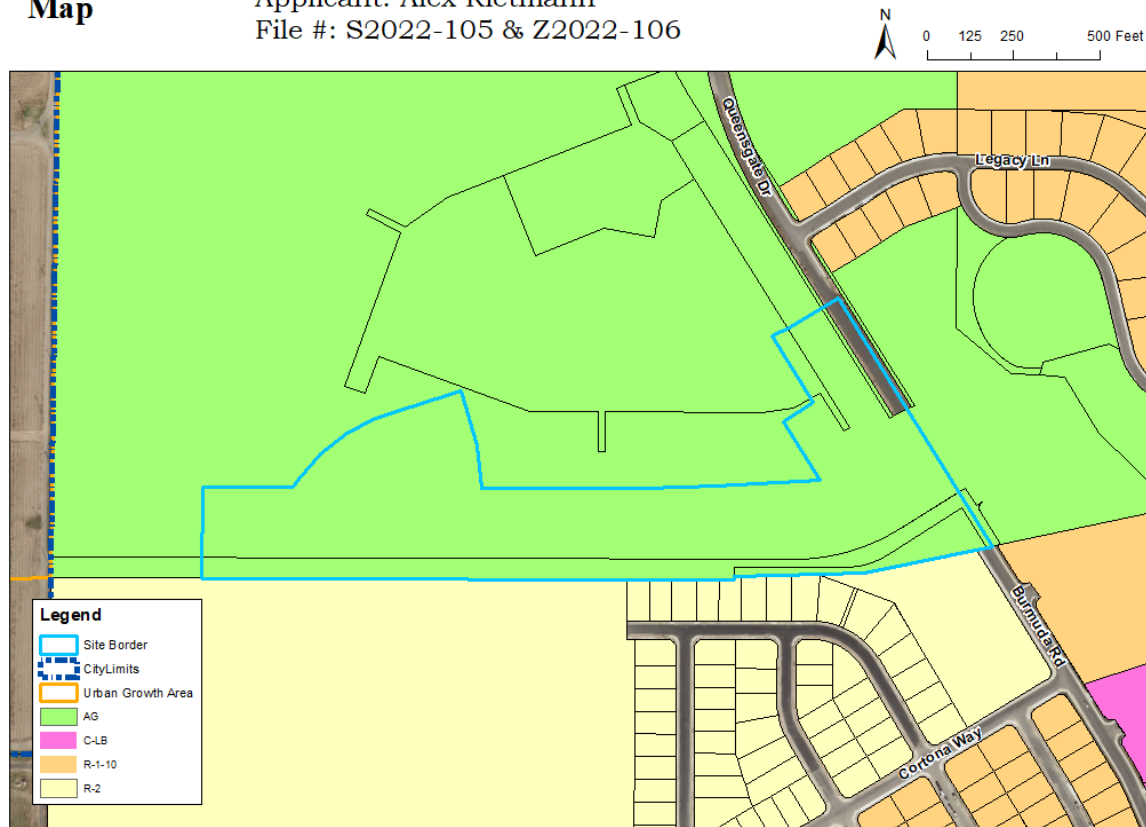
**Figure 3 – Zoning Map**

The Agricultural use district (AG) is a primary zone classification permitting essentially open land uses such as grazing lands or pasture, agriculture, and development of part-time small tract farming and other compatible uses of an open nature such as a cemetery, park, and recreational or similar uses on land which has favorable combinations of slope, climate, availability of water, or soil conditions. This zoning classification is intended to be applied to some portions of the city that are designated as agriculture or as urban reserve under the city of Richland comprehensive plan (RMC 23.14.010(A)).

The medium-density residential small lot (R-2S) is a residential zone classification permitting a higher density of population, encouraging small lot development conducive to energy conservation and to other factors contributing to the production of affordable housing, and including the establishment of duplex dwellings and providing for these one- and two-family residences a high degree of protection from hazards, objectionable influences, building congestion and lack of light, air and privacy. Certain essential and compatible public service facilities and institutions are

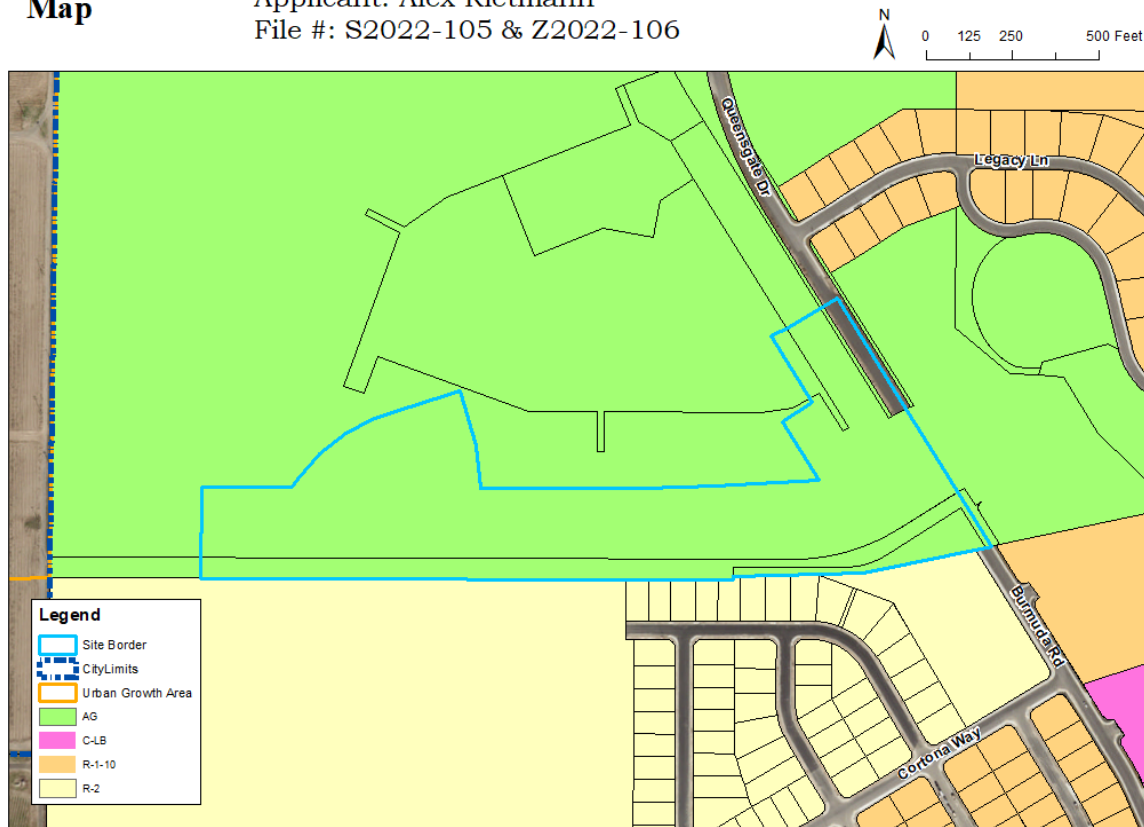
**Figure 3 – Zoning Map**

As indicated previously, the site is currently zoned Agricultural (AG). The Agricultural use district (AG) is a primary zone classification permitting essentially open land uses such as grazing lands or pasture, agriculture, and development of part-time small tract farming and other compatible uses of an open nature such as a cemetery, park, and recreational or similar uses on land which has favorable combinations of slope, climate, availability of water, or soil conditions. This zoning classification is intended to be applied to some portions of the city that are designated as agriculture or as urban reserve under the city of Richland comprehensive plan (RMC 23.14.010(A)).

Parallel to this preliminary plat approval, the applicant is also requesting a zoning change to R-2S. The medium-density residential small lot (R-2S) is a residential zone classification permitting a higher density of population, encouraging small lot development conducive to energy conservation and to other factors contributing to the production of affordable housing, and including the establishment of duplex dwellings and providing for these one- and two-family residences a high degree of protection from hazards, objectionable influences, building congestion and lack of light, air and privacy. Certain essential and compatible public service facilities and institutions are permitted in this district. This zoning classification is intended to be applied to some portions of the city that are designated medium-density residential (5.1 to 10 dwellings per acre) under the city of Richland comprehensive plan. (RMC 23.18.010(D)).

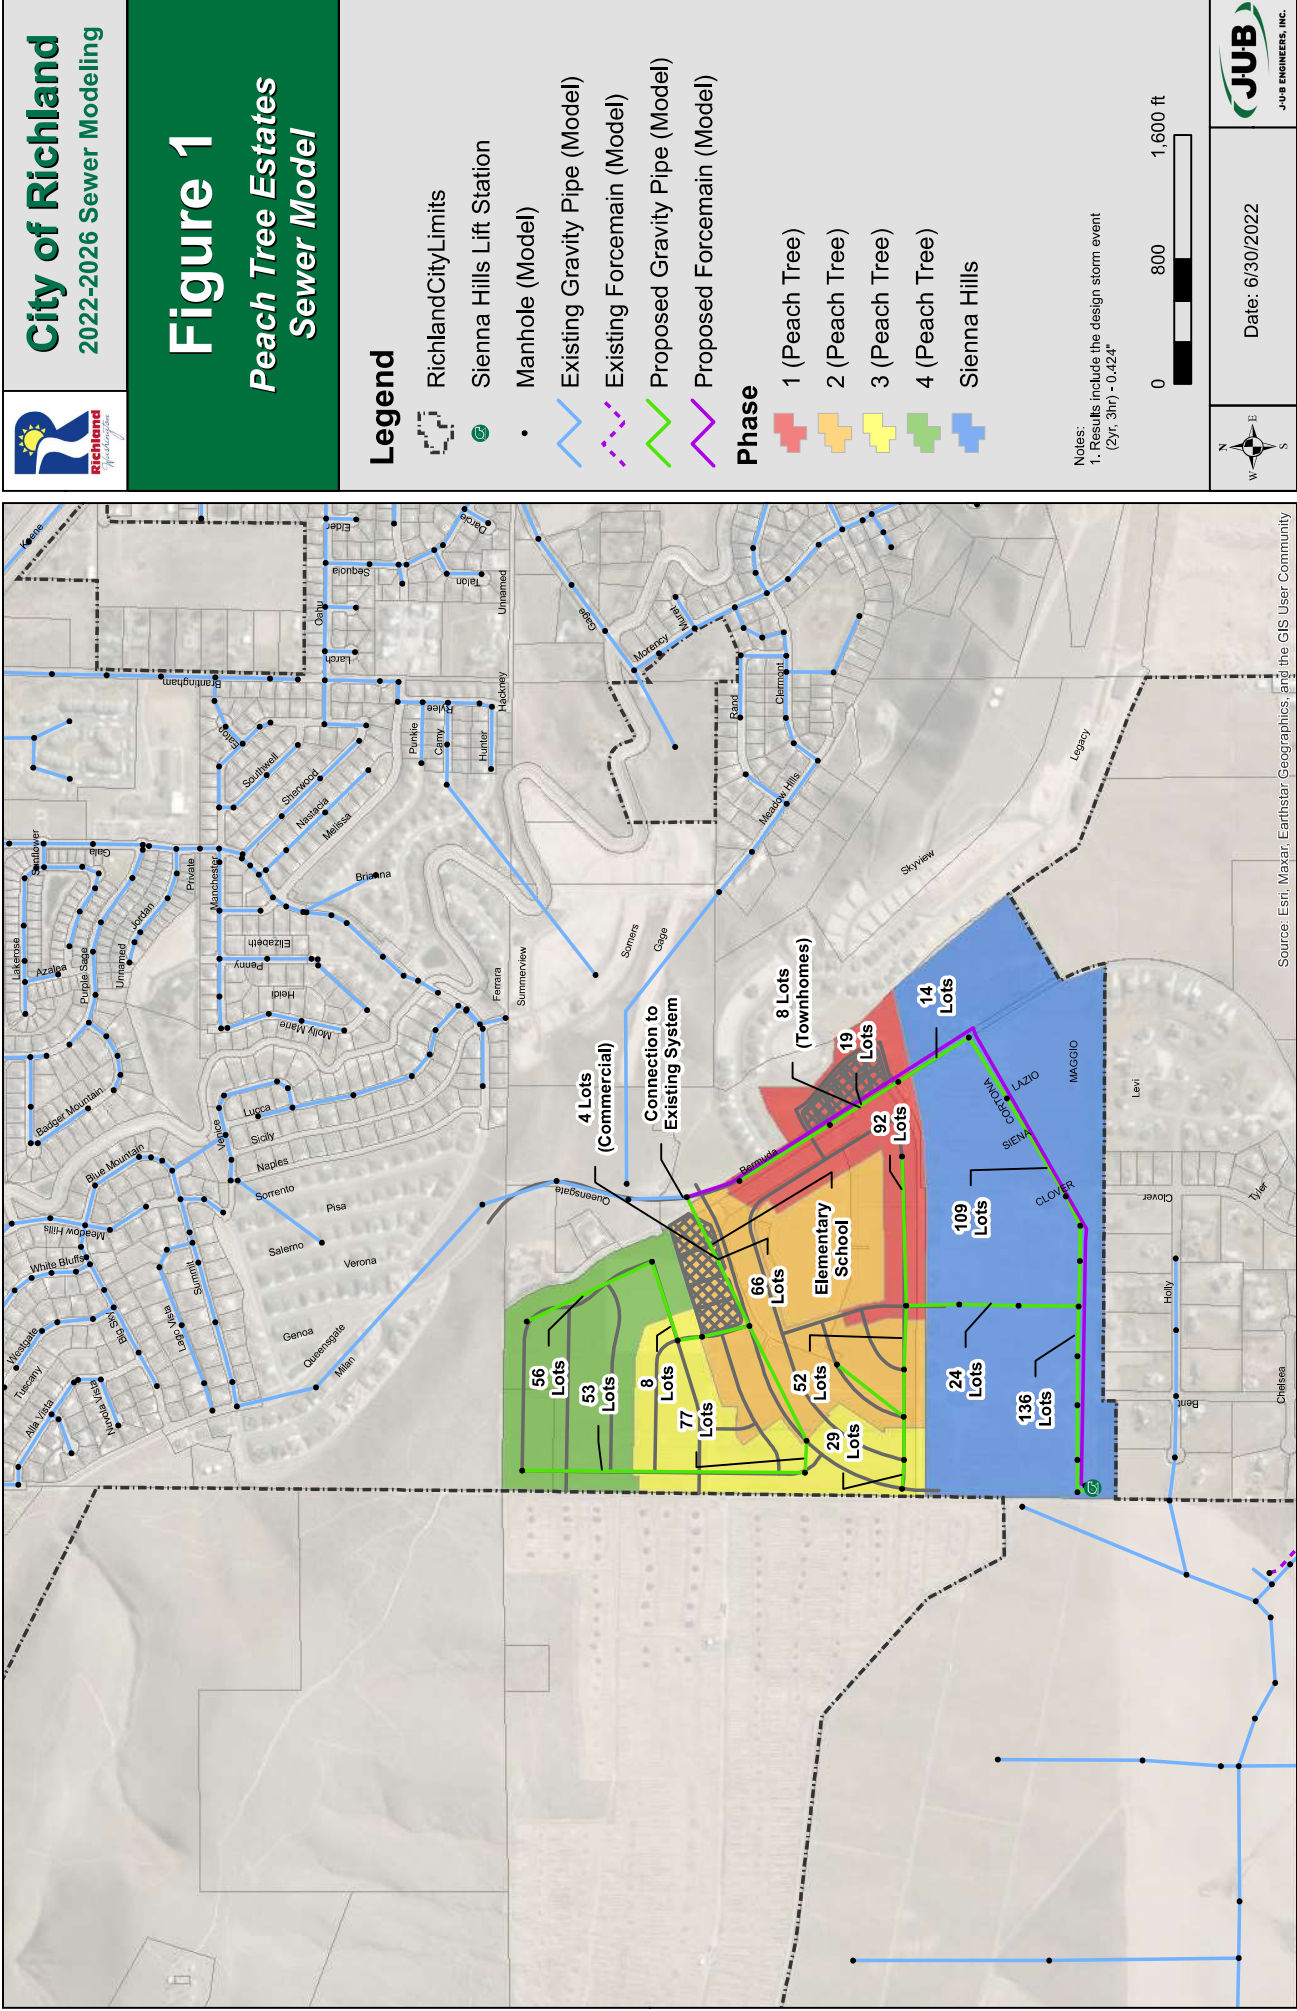
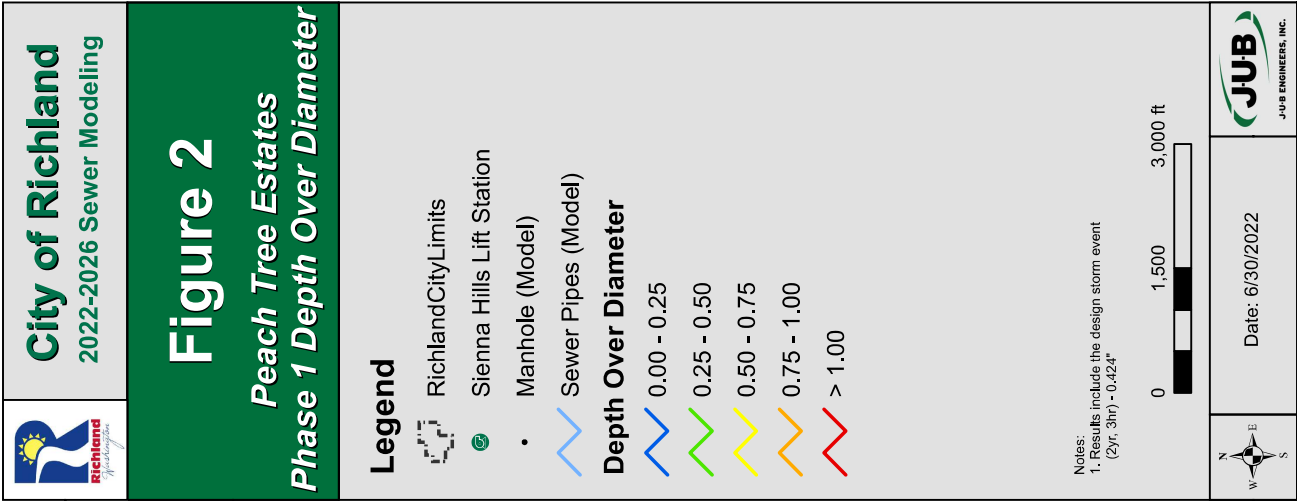
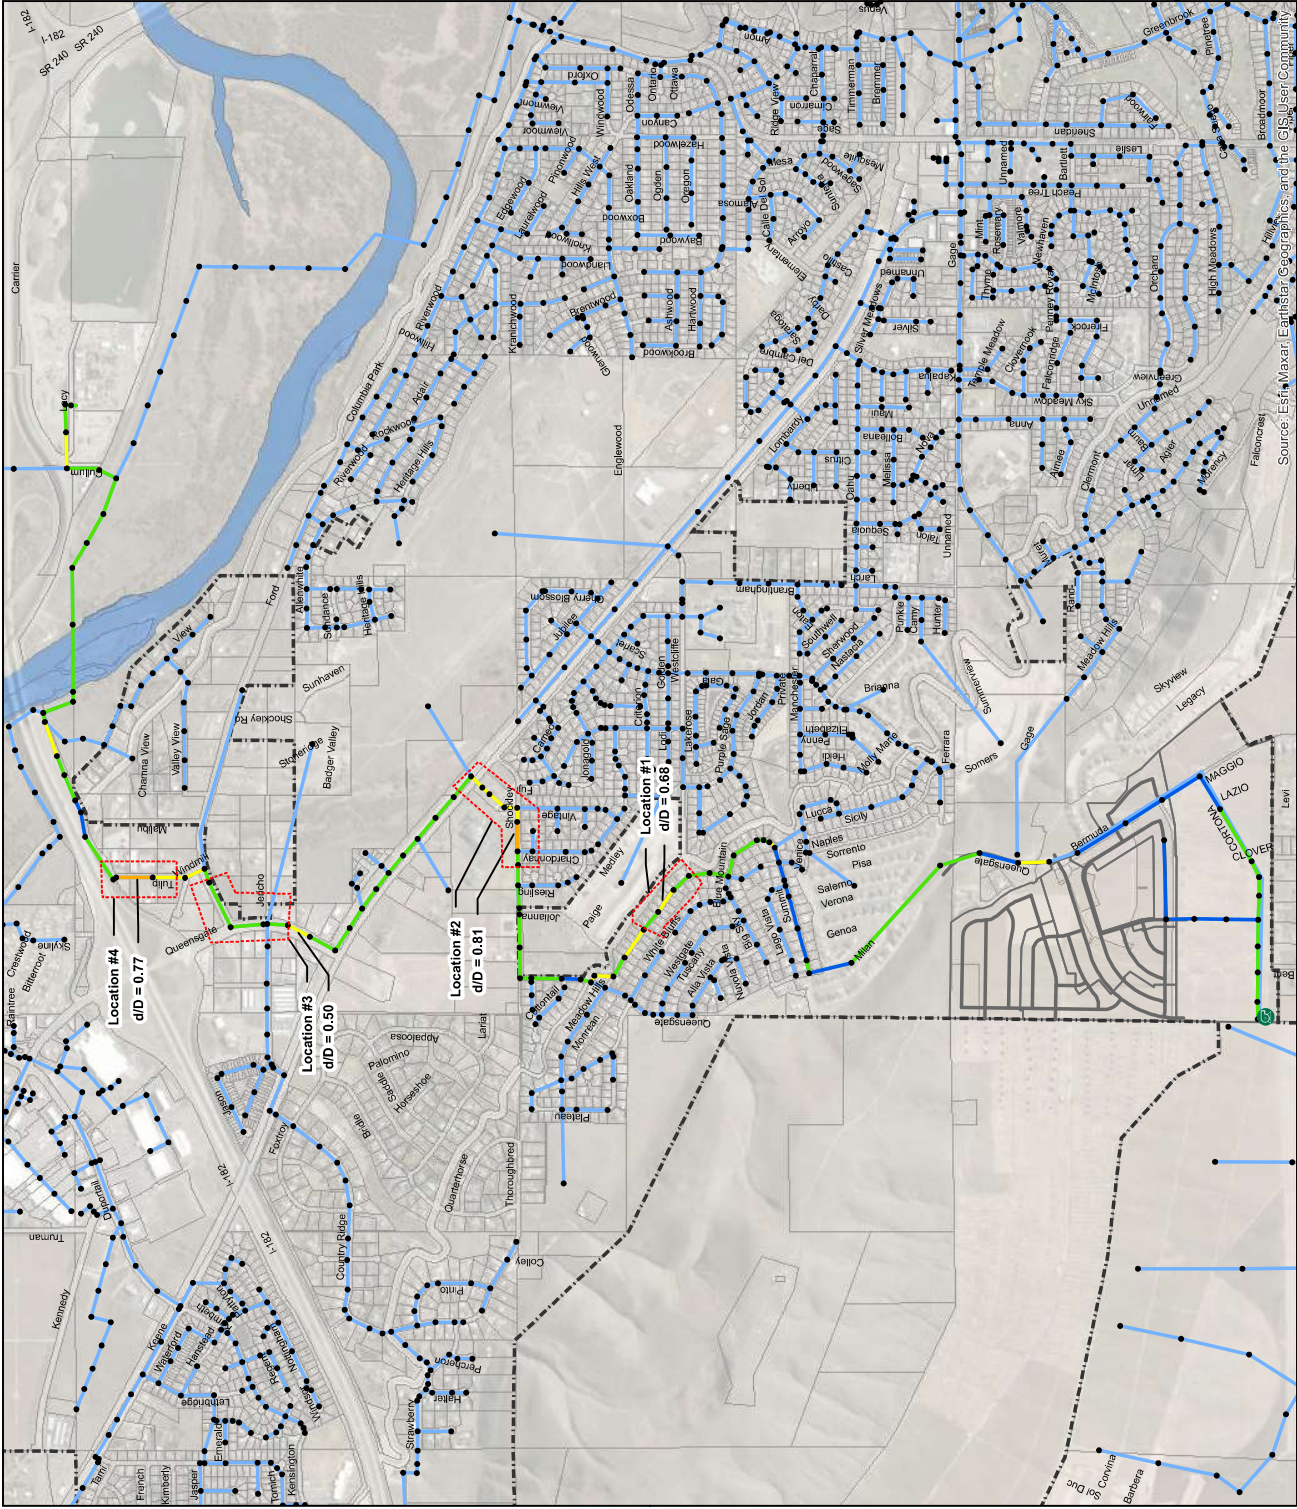
The existing piping is adequate for phases 1 through 3 without any surcharging. Recommended improvements to eliminate surcharging is shown in Figure 7. Since the surcharging during Phase 4 is only 1.07 inches, it appears that existing pipe is adequate (depending on the City's risk tolerance). In order to better correlate actual flow conditions to modeled flows, and to lessen the risk of sanitary sewer overflows, sewer monitoring could be done at each of the four bottleneck locations. One way to monitor water depth is to hang an ultrasonic level sensor so that depths can be monitored over time. This could provide valuable information as phases progress for determining if and when improvements should be done.

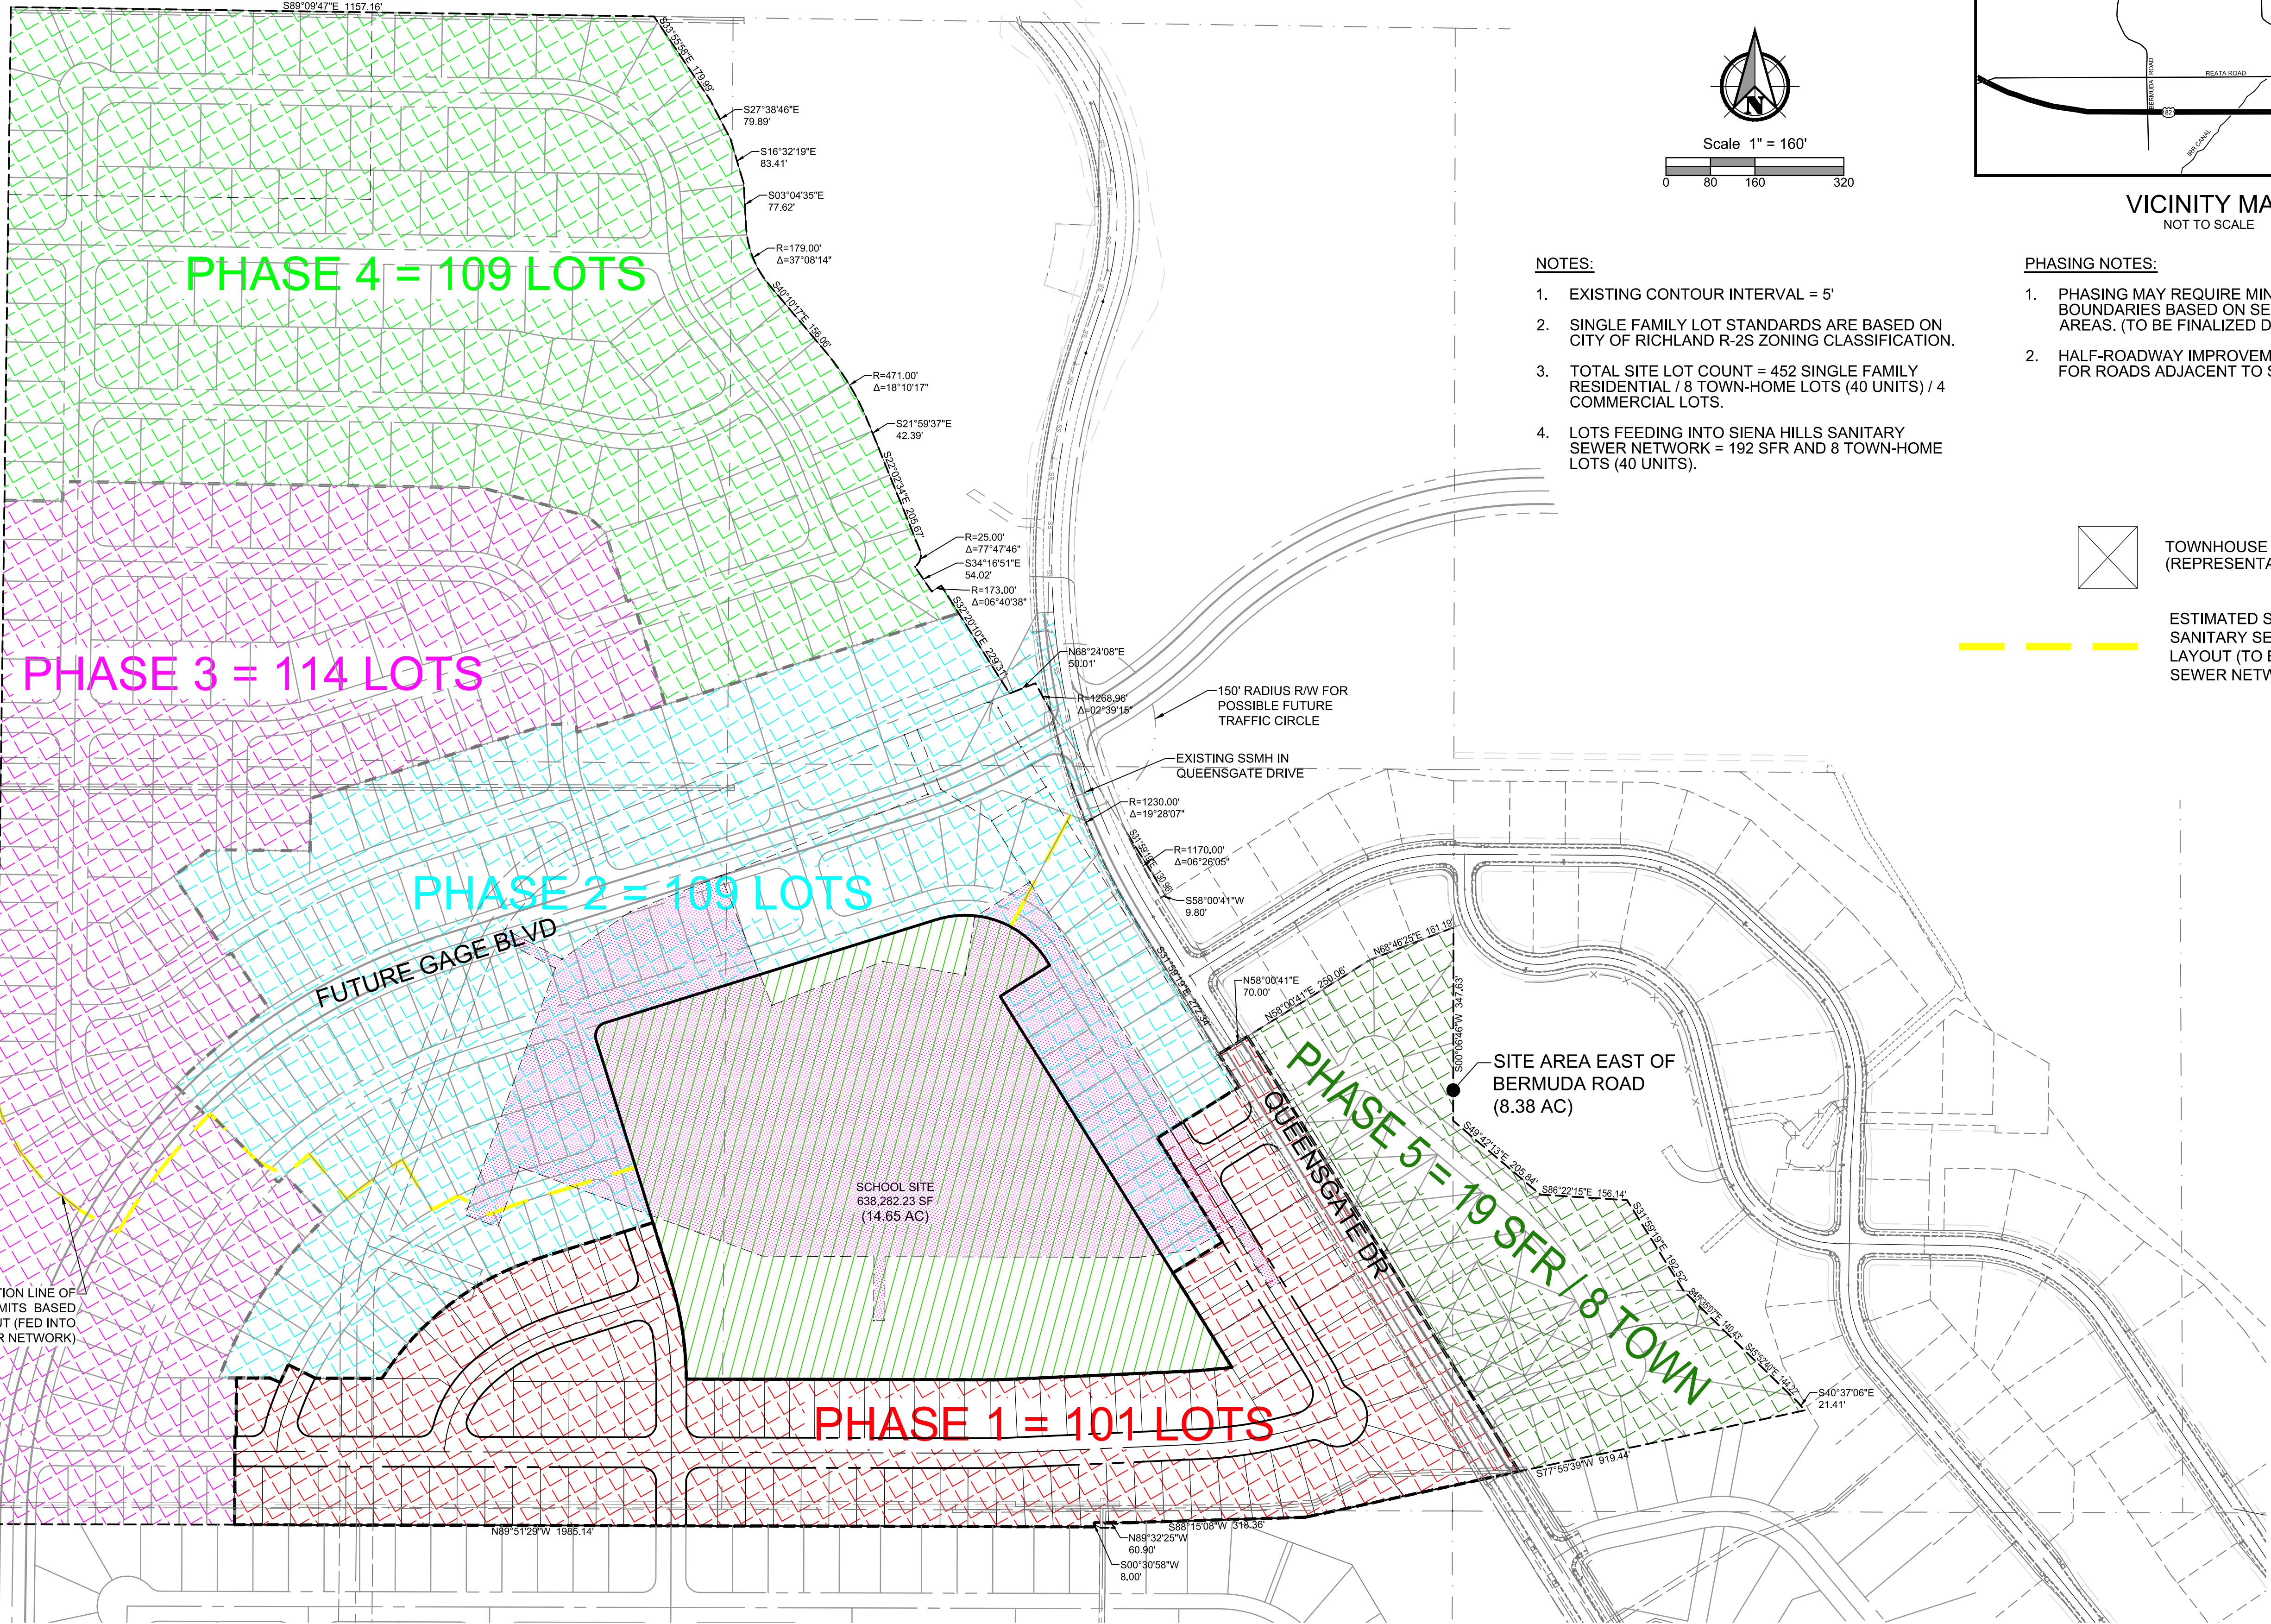
OVERALL SITE PHASING PLAN FOR:  
**PEACH TREE ESTATES**  
A RESIDENTIAL SUBDIVISION IN THE CITY OF RICHLAND, WA.

ESTIMATED SEPARATION LINE OF  
SANITARY SEWER LIMITS BASED ON LOT  
LAYOUT (TO BE FED INTO SIENA HILLS  
SEWER NETWORK TO THE SOUTH)

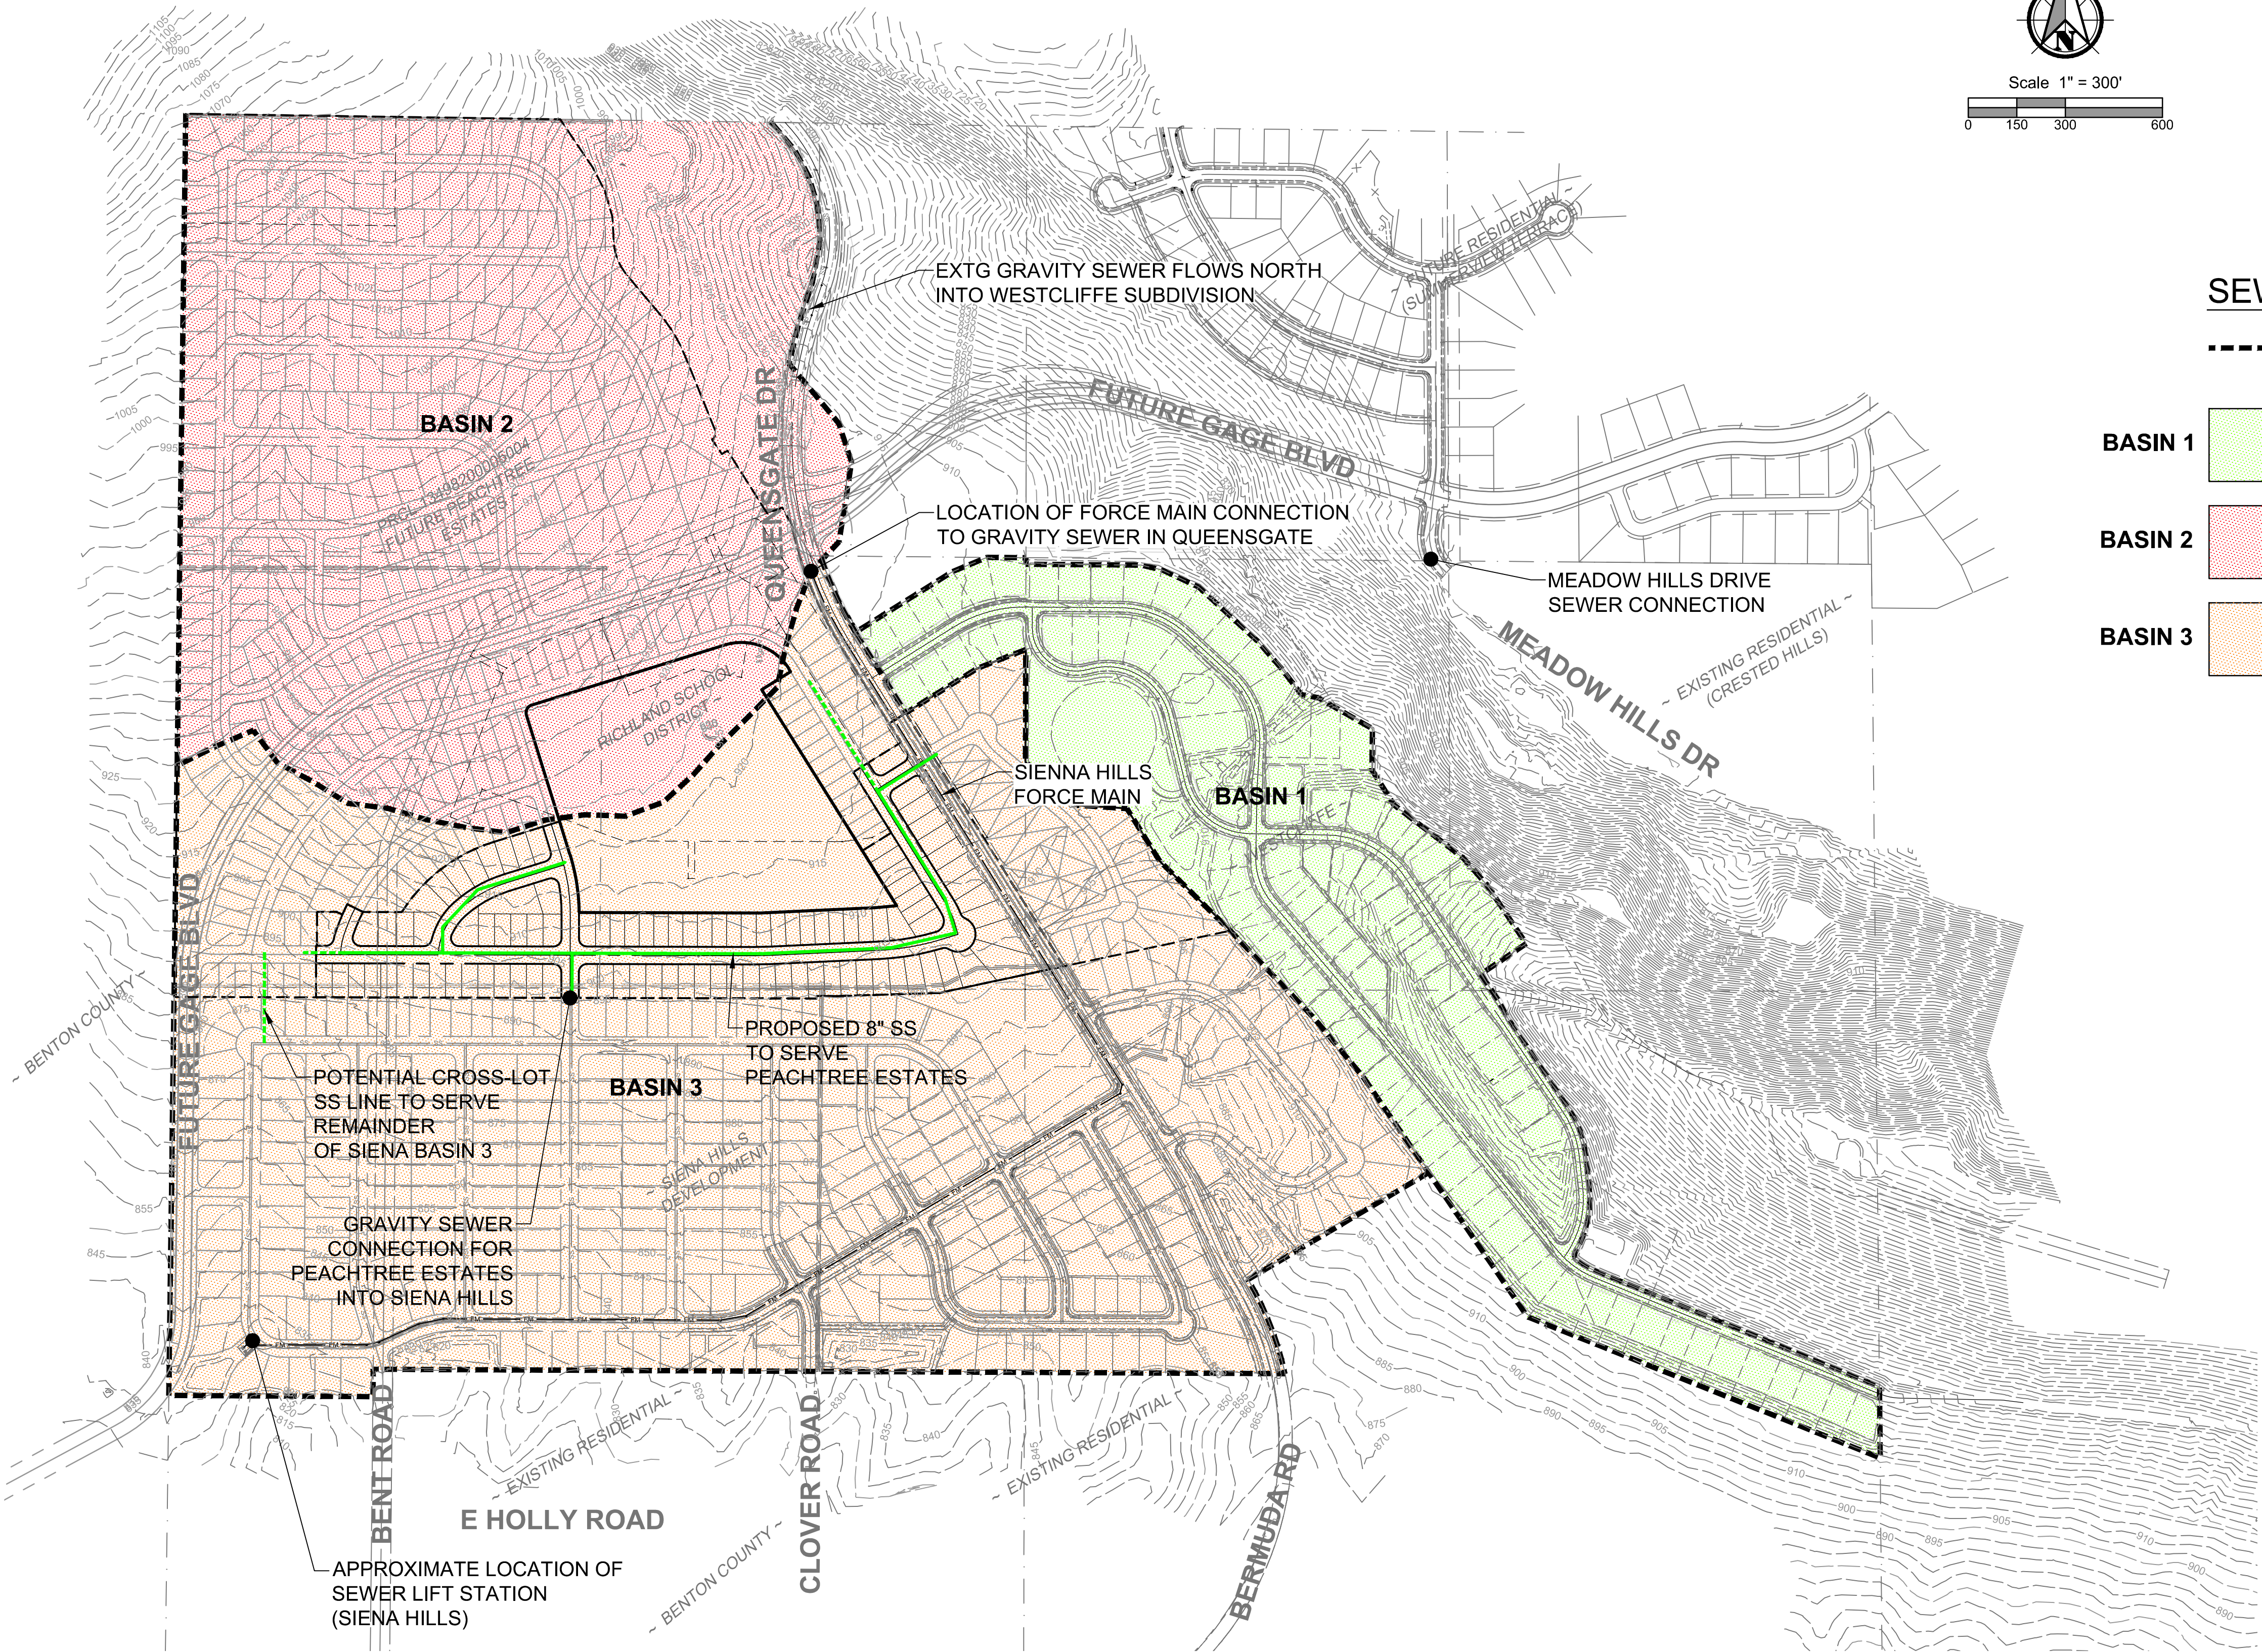
SEWER BASIN AREA ANALYSIS FOR:

- BASIN 1** MEADOW HILLS DRIVE CONNECTION (GRAVITY) (WESTCLIFFE HEIGHTS) (45 ACRES)
- BASIN 2** QUEENSGATE DRIVE CONNECTION (GRAVITY) (92 ACRES)
- BASIN 3** QUEENSGATE DRIVE CONNECTION (PUMPED) (PUMP STATION INSTALLED IN SIENNA HILLS) (150 ACRES)

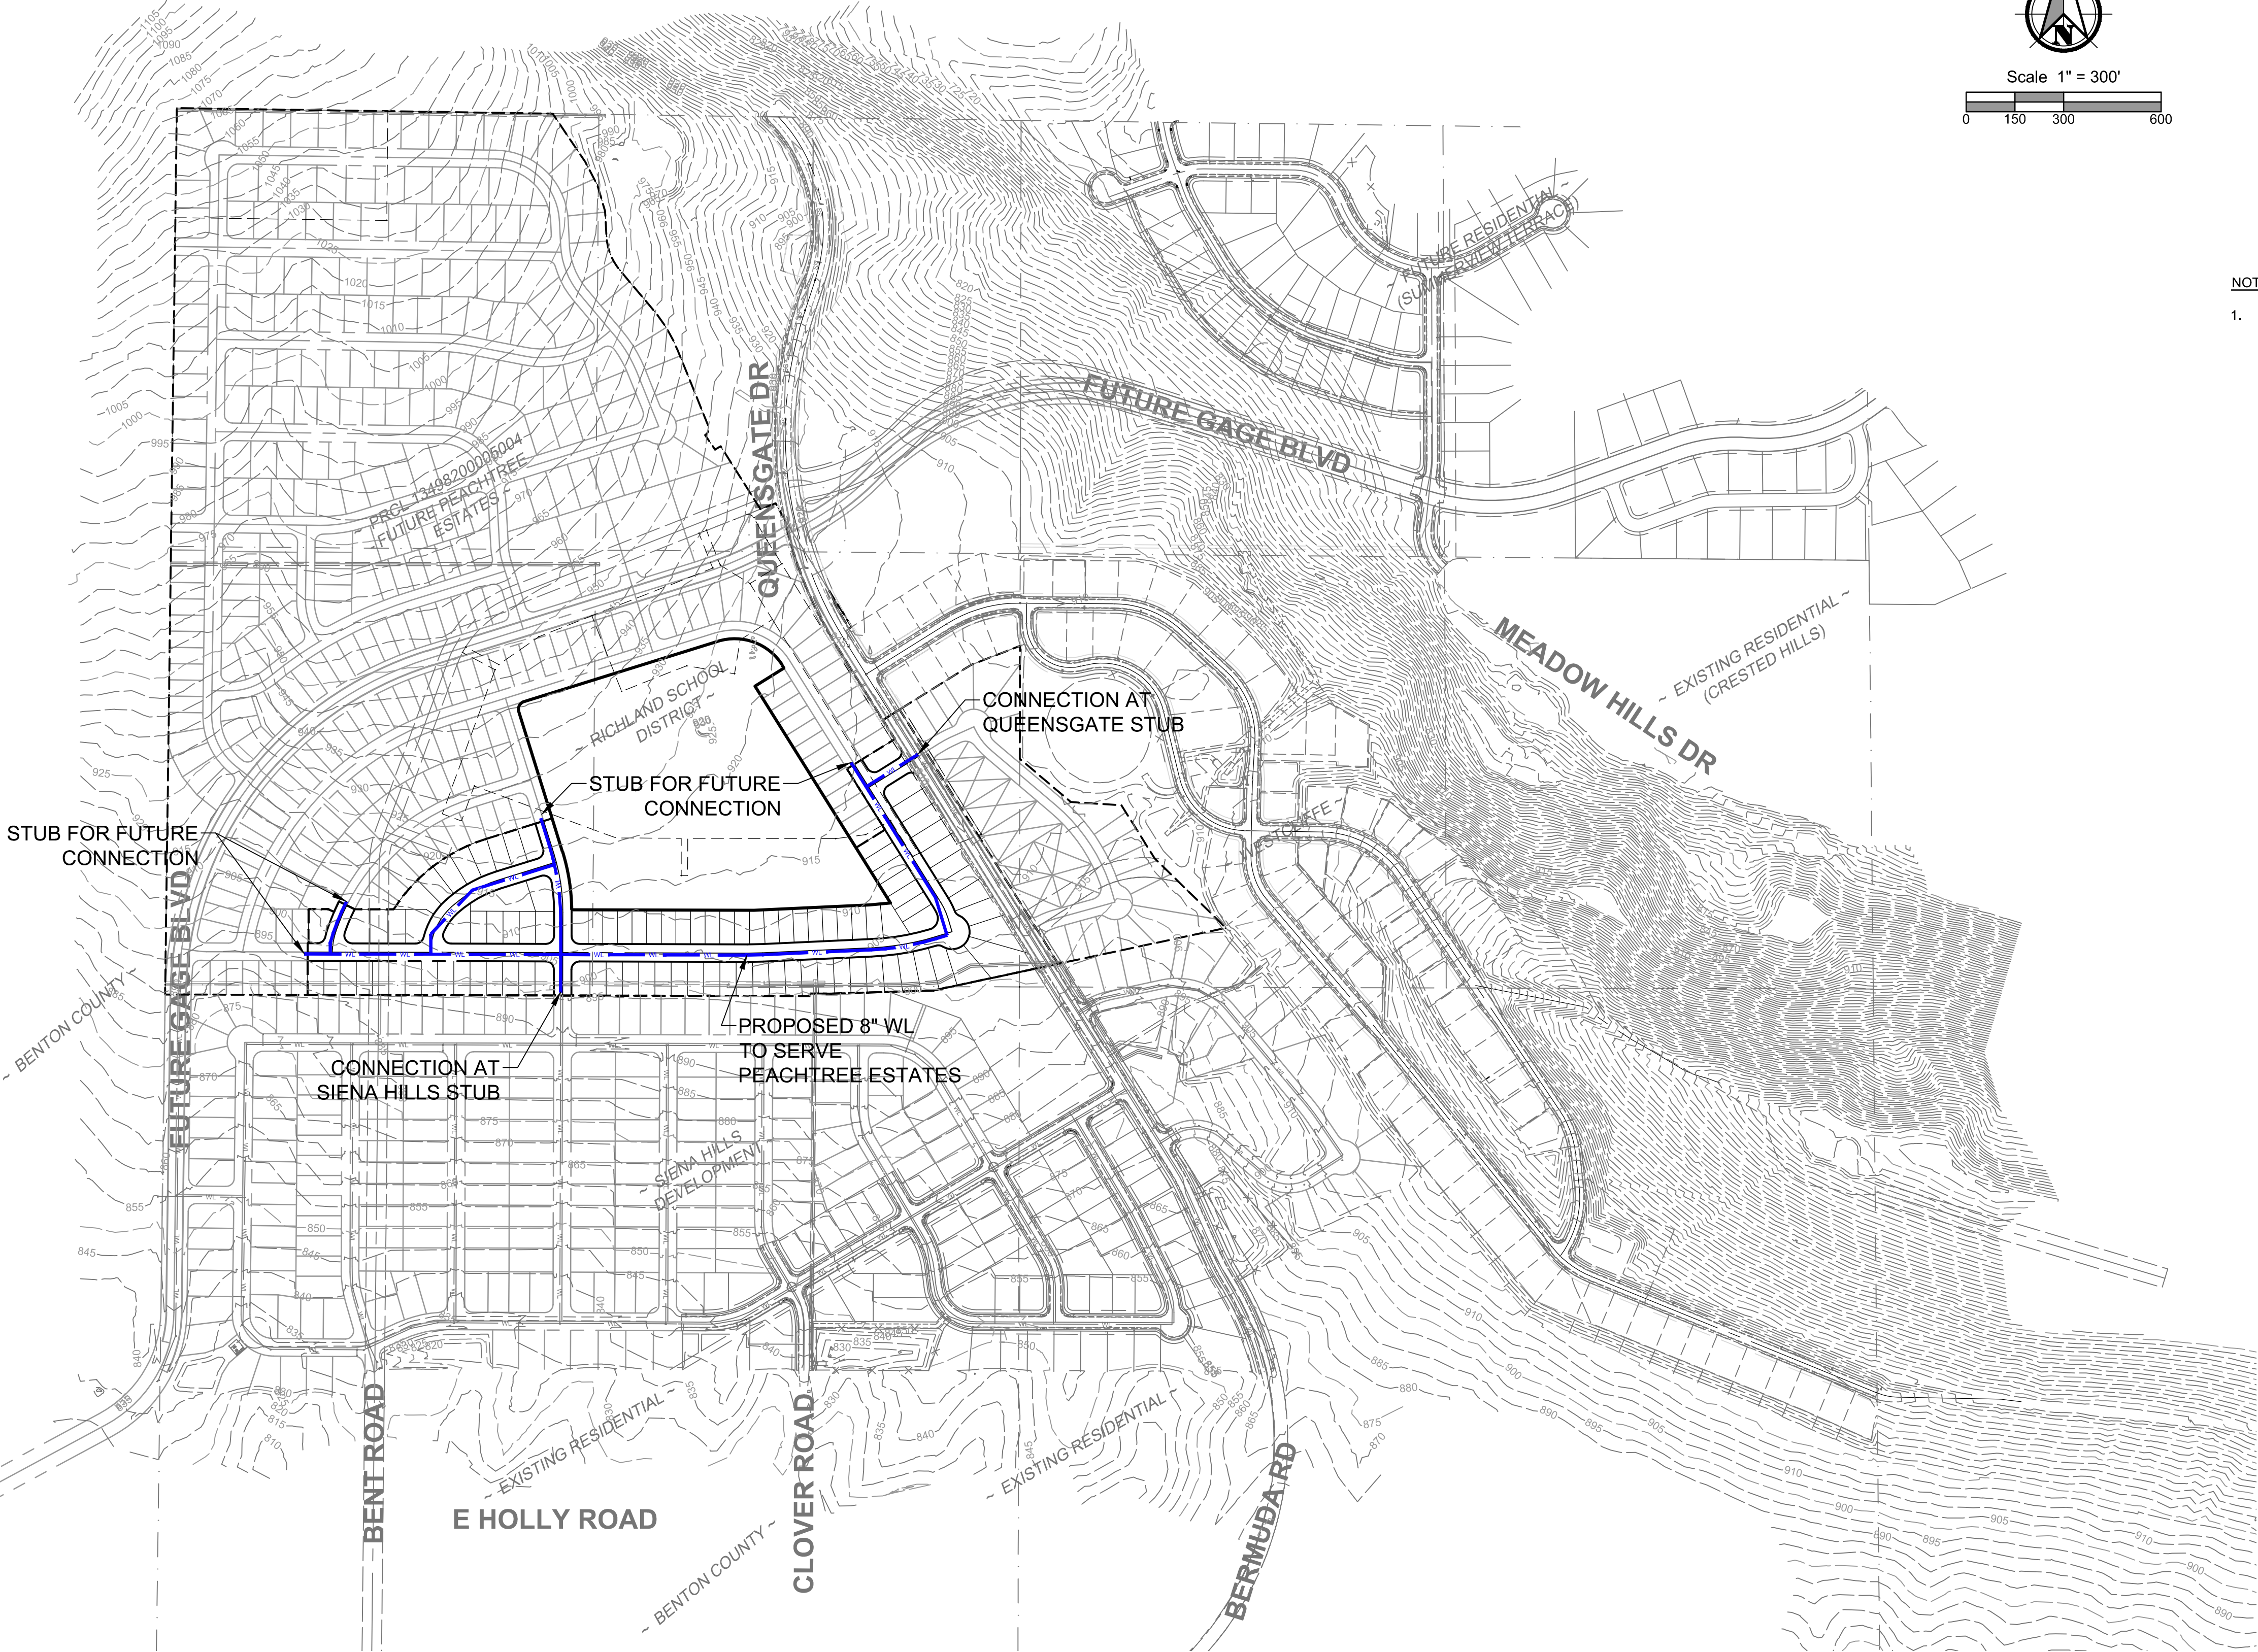
**WATER SYSTEM ROUTING EXHIBIT FOR:**

1. WATERLINE IN PLAT SHALL BE 8" MINIMUM DIAMETER PVC BUILT TO CITY OF RICHLAND STANDARDS.
